**Draft Report
Project No. 60251**

**Volume 1 of 5
Remedial Investigation Report
ACS NPL Site
Griffith, Indiana**

**REMEDIAL INVESTIGATION REPORT
AMERICAN CHEMICAL SERVICES NPL SITE
GRIFFITH, INDIANA**

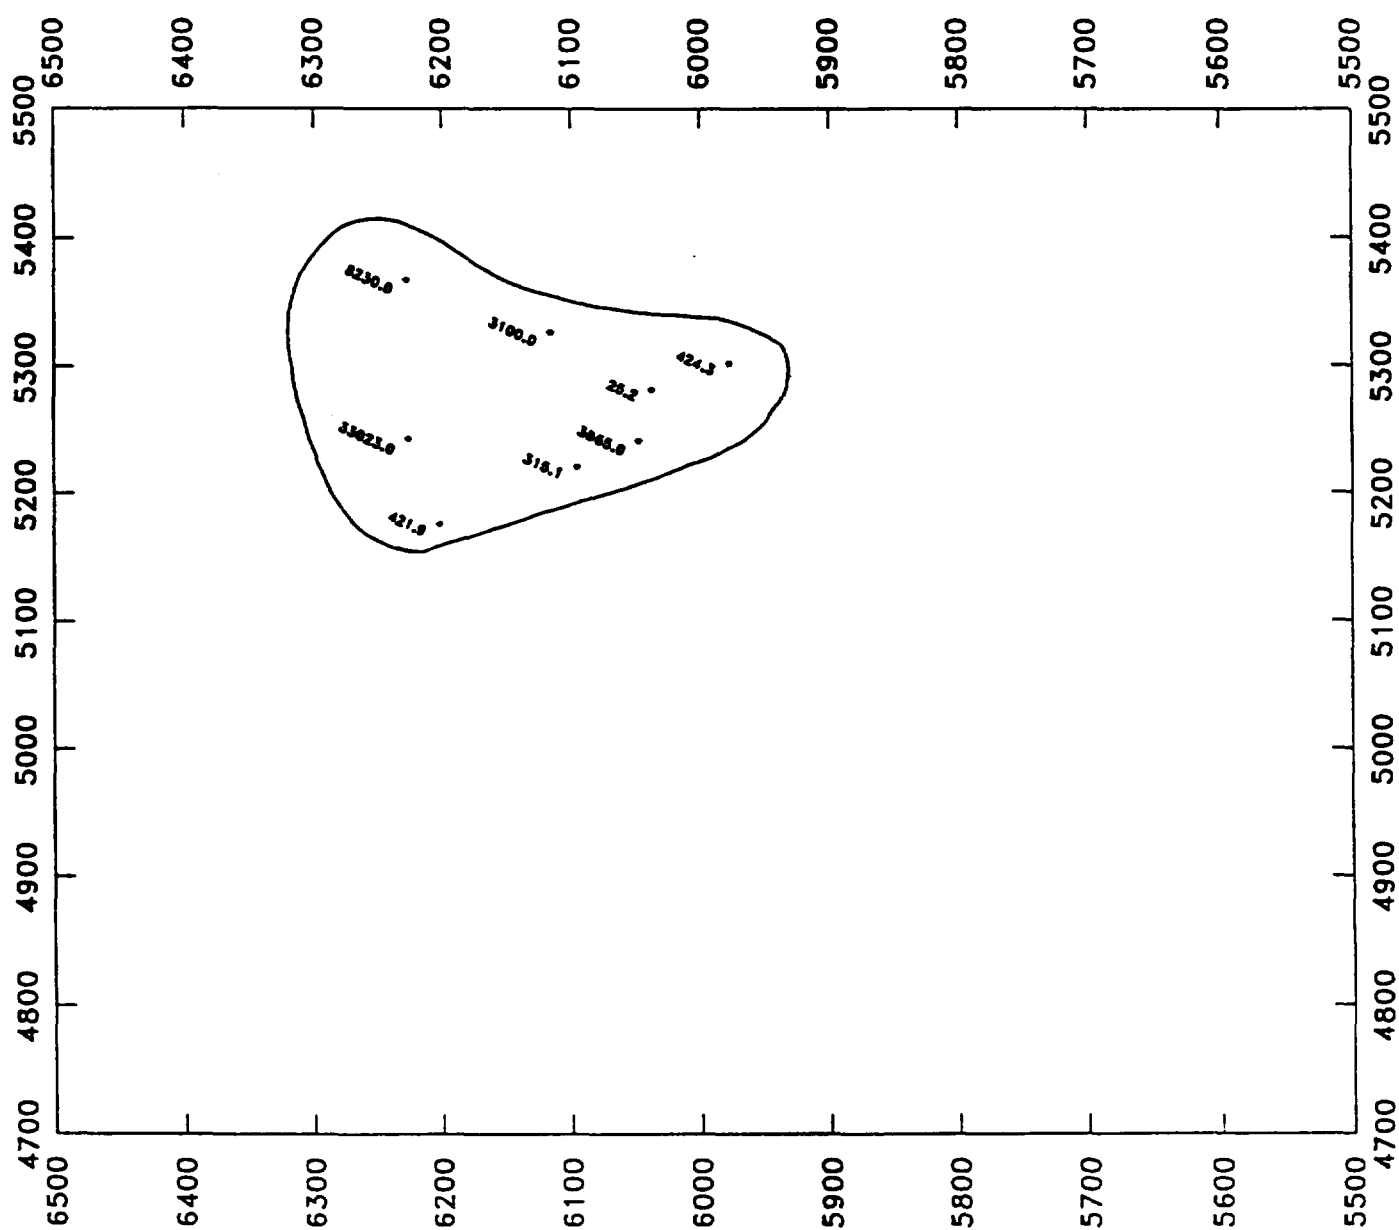
Figure 5-9e Approximate Extent of Total Volatile Wastes (> 1 ppm), Off-Site Areas (14-19 feet below surface). Posted Values are in ppm (mg/kg).

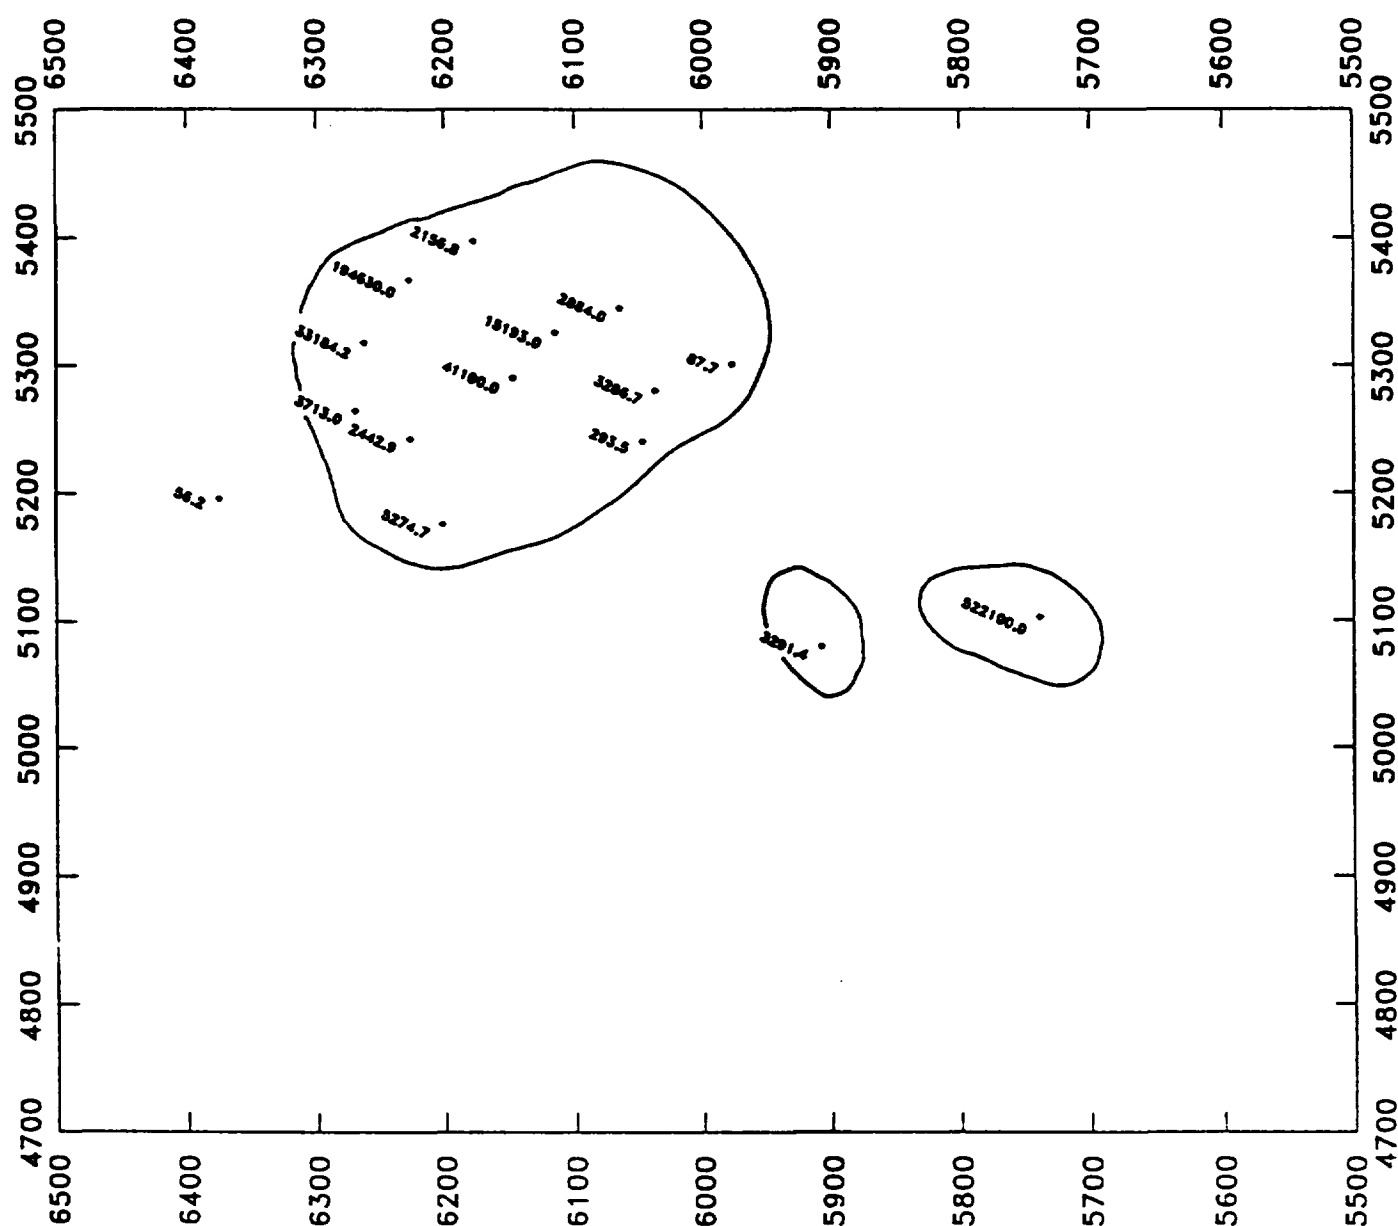
Figure 5-9d Approximate Extent of Total Volatile Wastes (> 1 ppm), Off-Site Areas (9-14 feet below surface). Posted Values are in ppm (mg/kg).

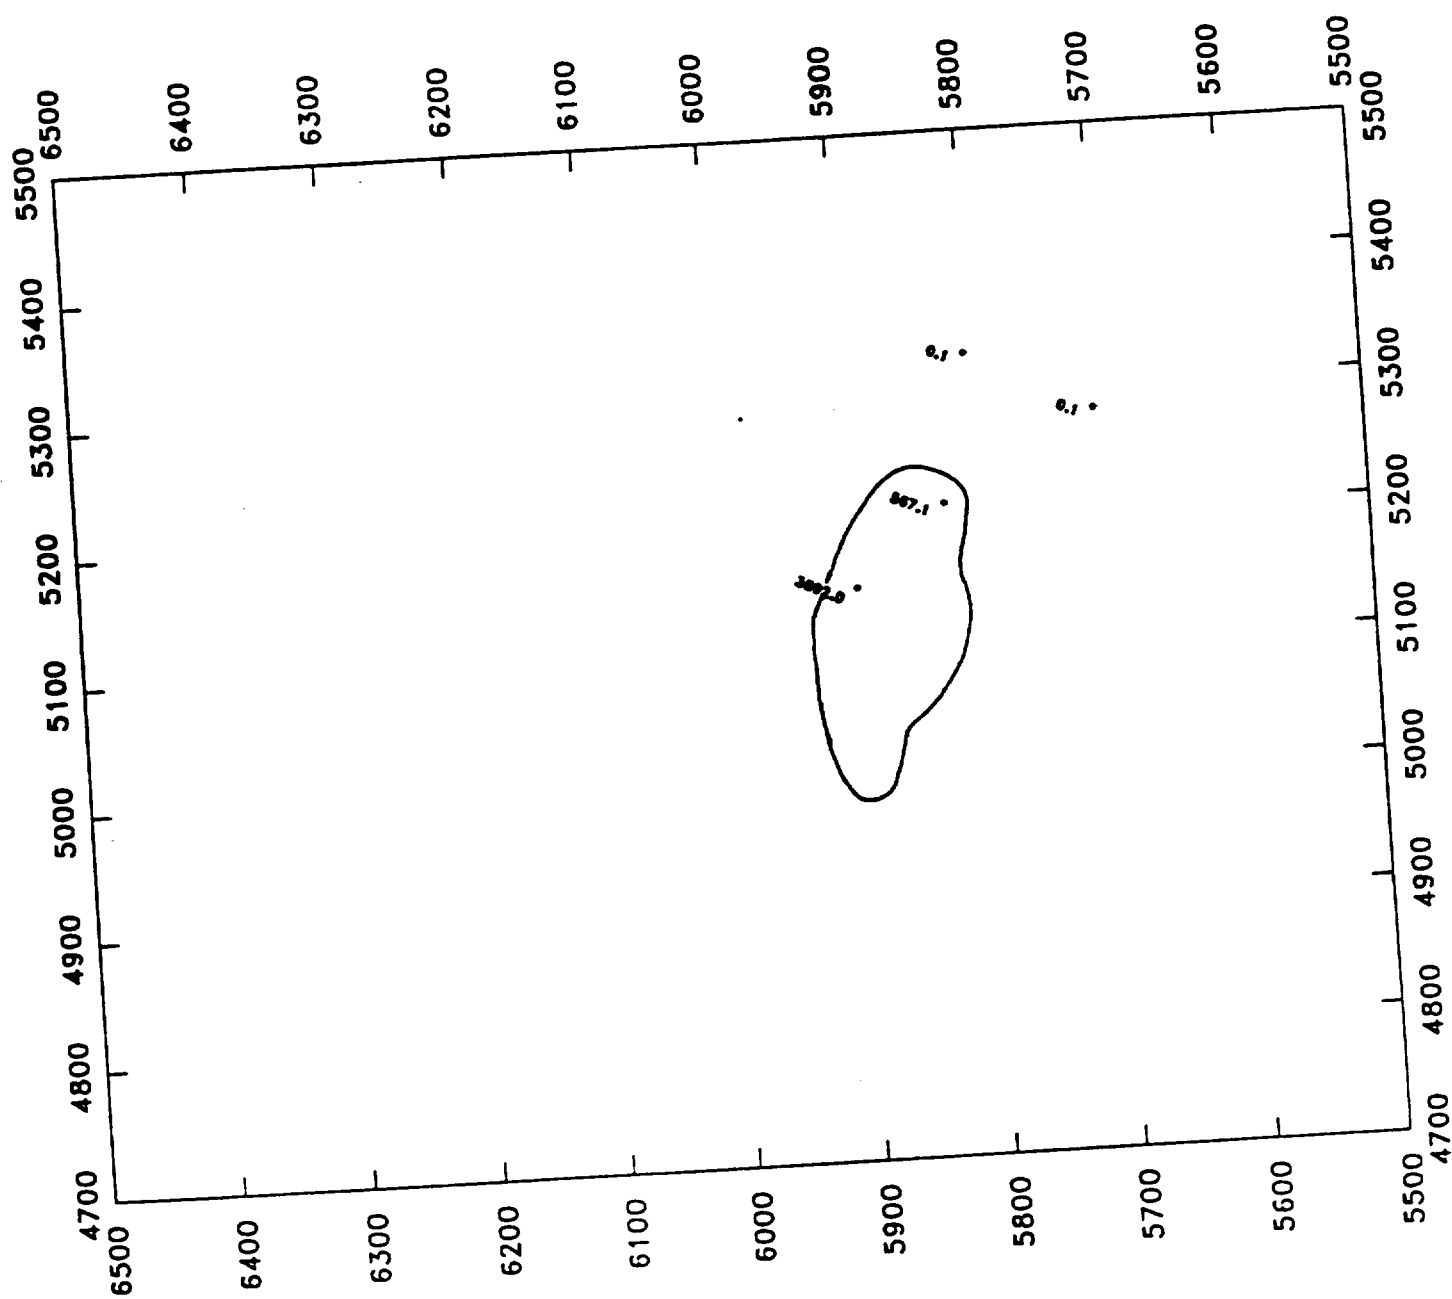
Figure 5-9c Approximate Extent of Total Volatile Wastes (> 1 ppm), Off-Site Areas (7.9 feet below surface). Posted Values are in ppm (mg/kg).

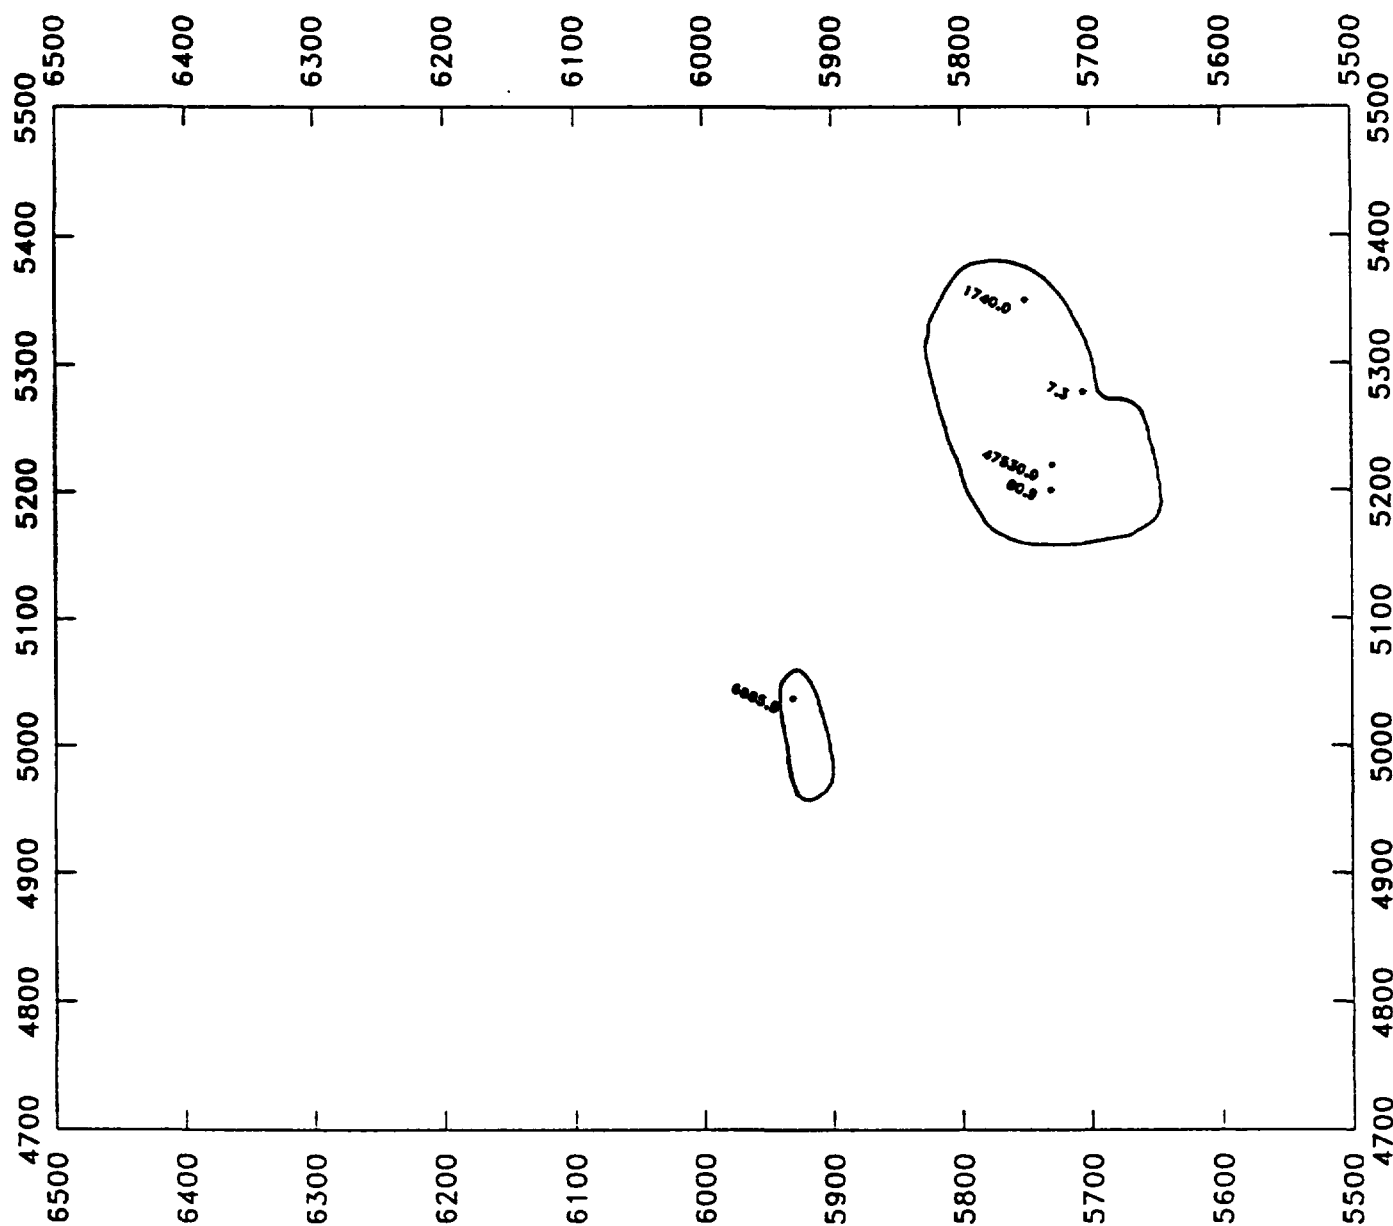
Figure 5.9a Approximate Extent of Total Volatile Wastes (> 1 ppm), Off-Site Areas (0-4 feet below surface). Posted Values are in ppm (mg/kg).

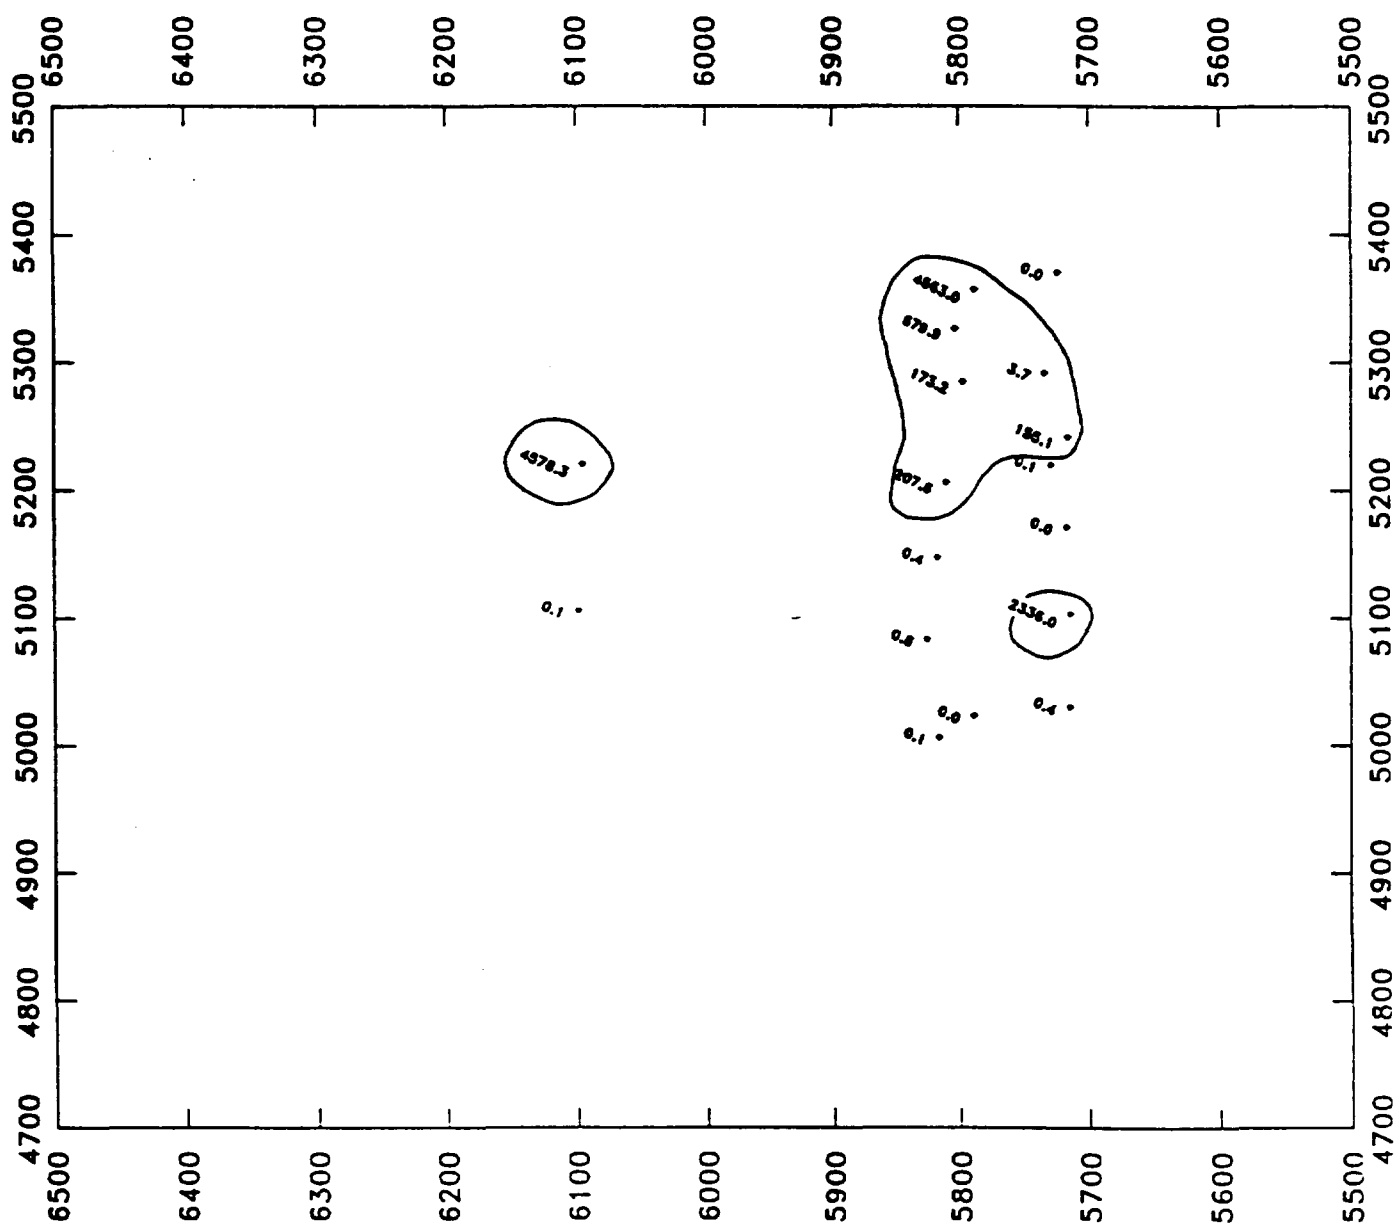
Figure 5-9b Approximate Extent of Total Volatile Wastes (> 1 ppm), Off-Site Areas (4-7 feet below surface). Posted Values are in ppm (mg/kg).

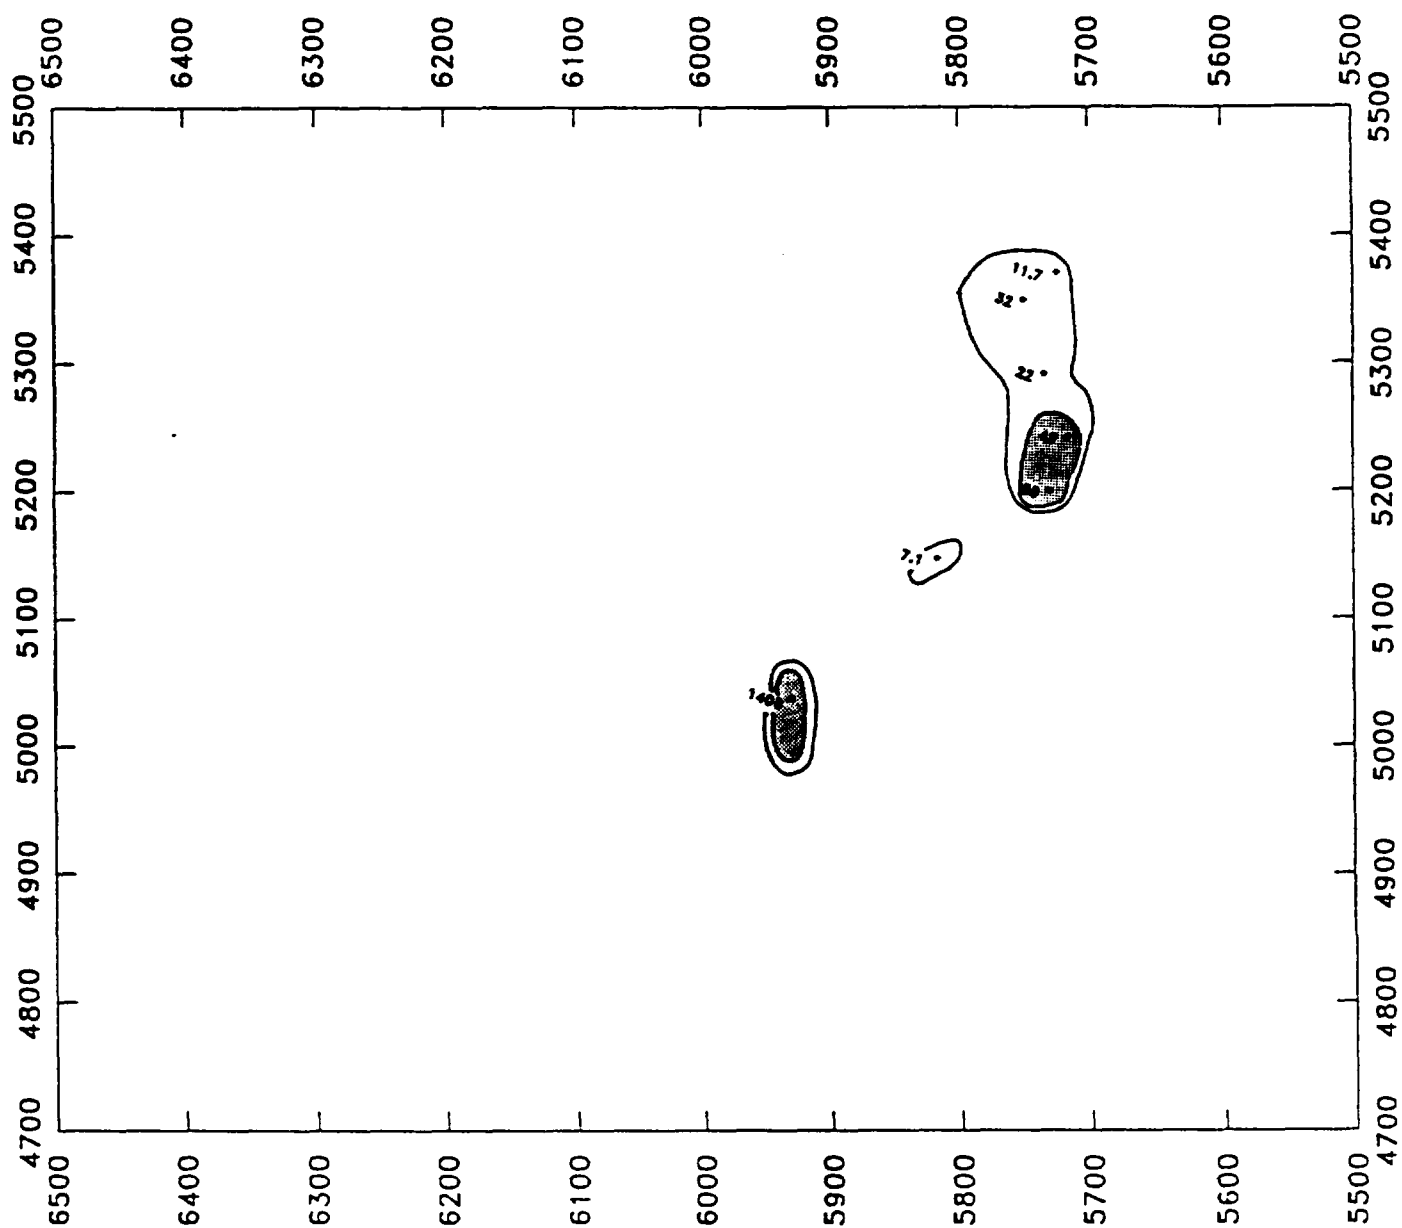
Figure 5-10a Approximate Extent of Total PCB Containing Wastes (> 1 ppm, shaded > 50 ppm), Off-Site Areas (0-3 feet below surface)

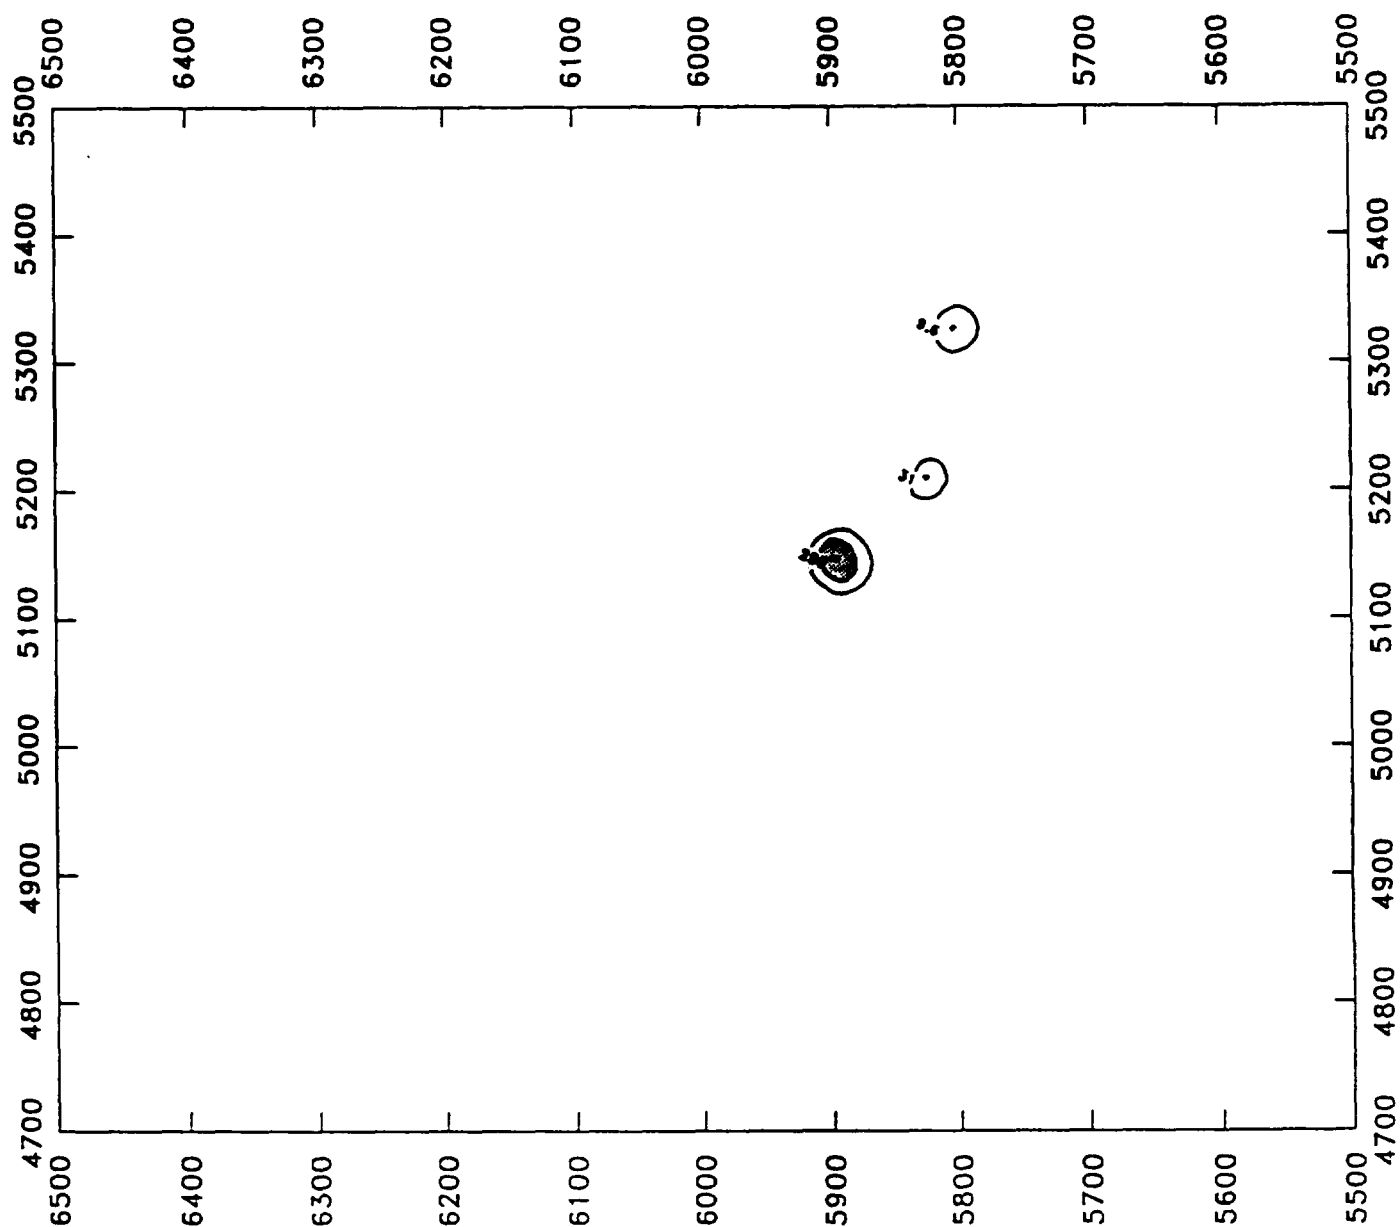
Figure 5-10c Approximate Extent of Total PCB Containing Wastes (> 1 ppm, shaded > 50 ppm), Off-Site Areas (6-8 feet below surface)

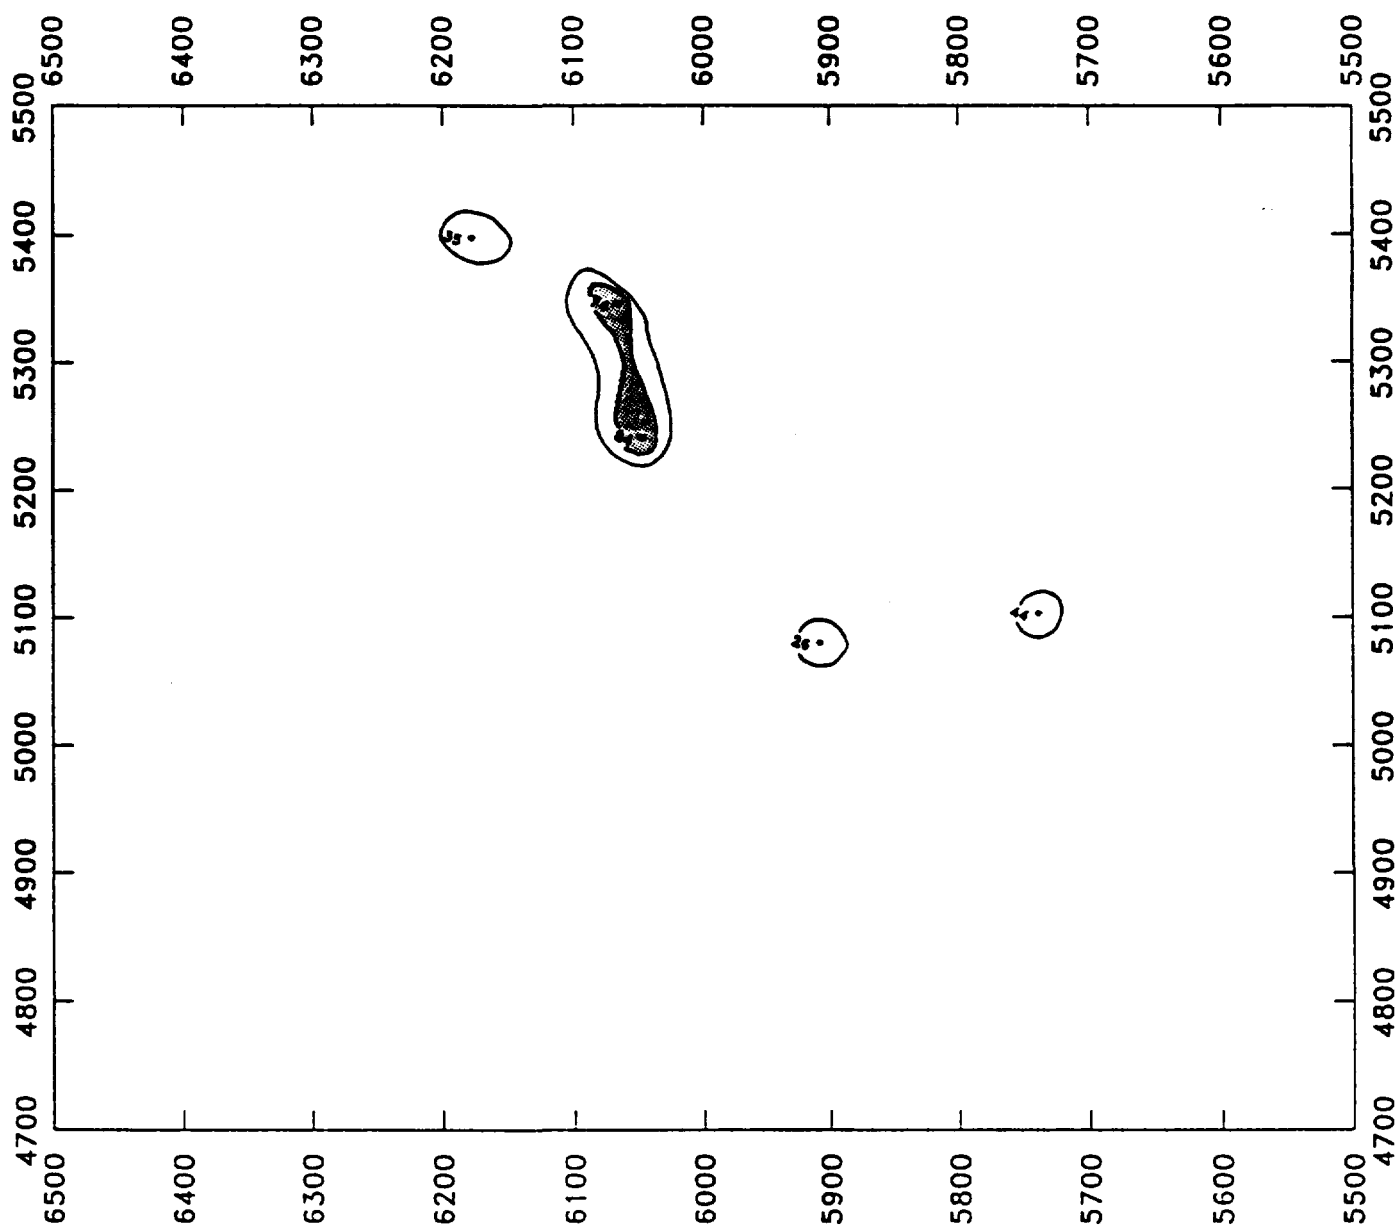
Figure 5-10d Approximate Extent of Total PCB Containing Wastes (> 1 ppm, shaded > 50 ppm), Off-Site Areas (8-12 feet below surface)

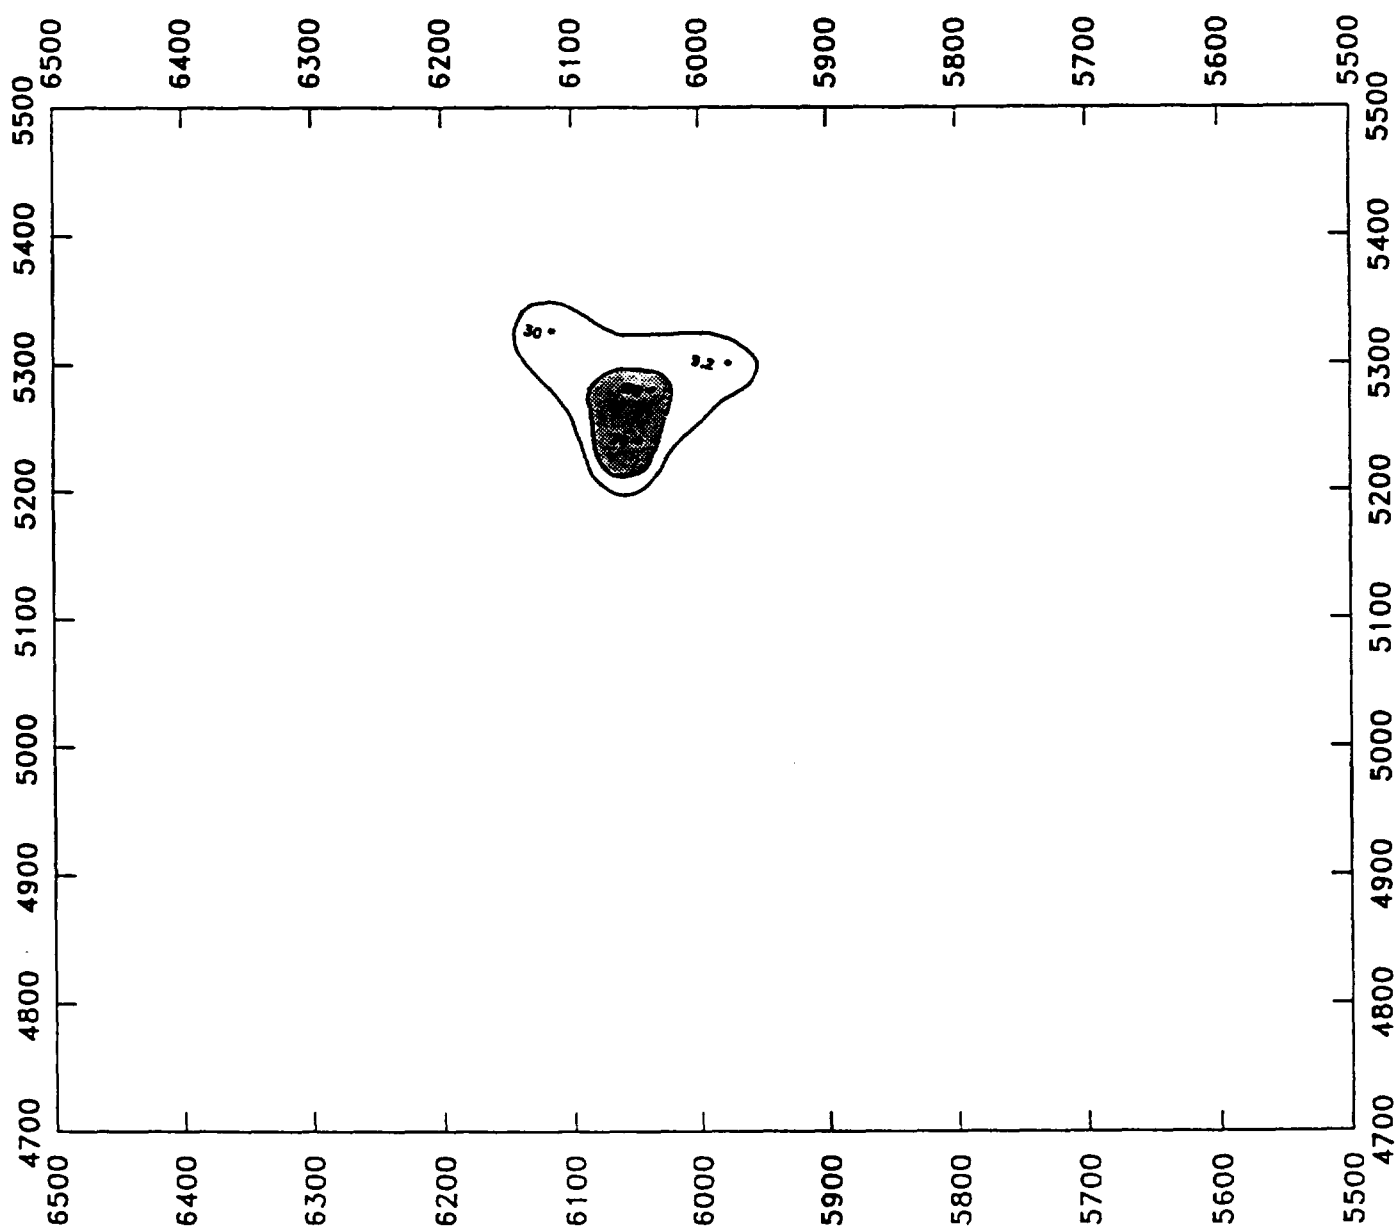
Figure 5-10e Approximate Extent of Total PCB Containing Wastes (> 1 ppm, shaded > 50 ppm), Off-Site Areas (12-17 feet below surface)

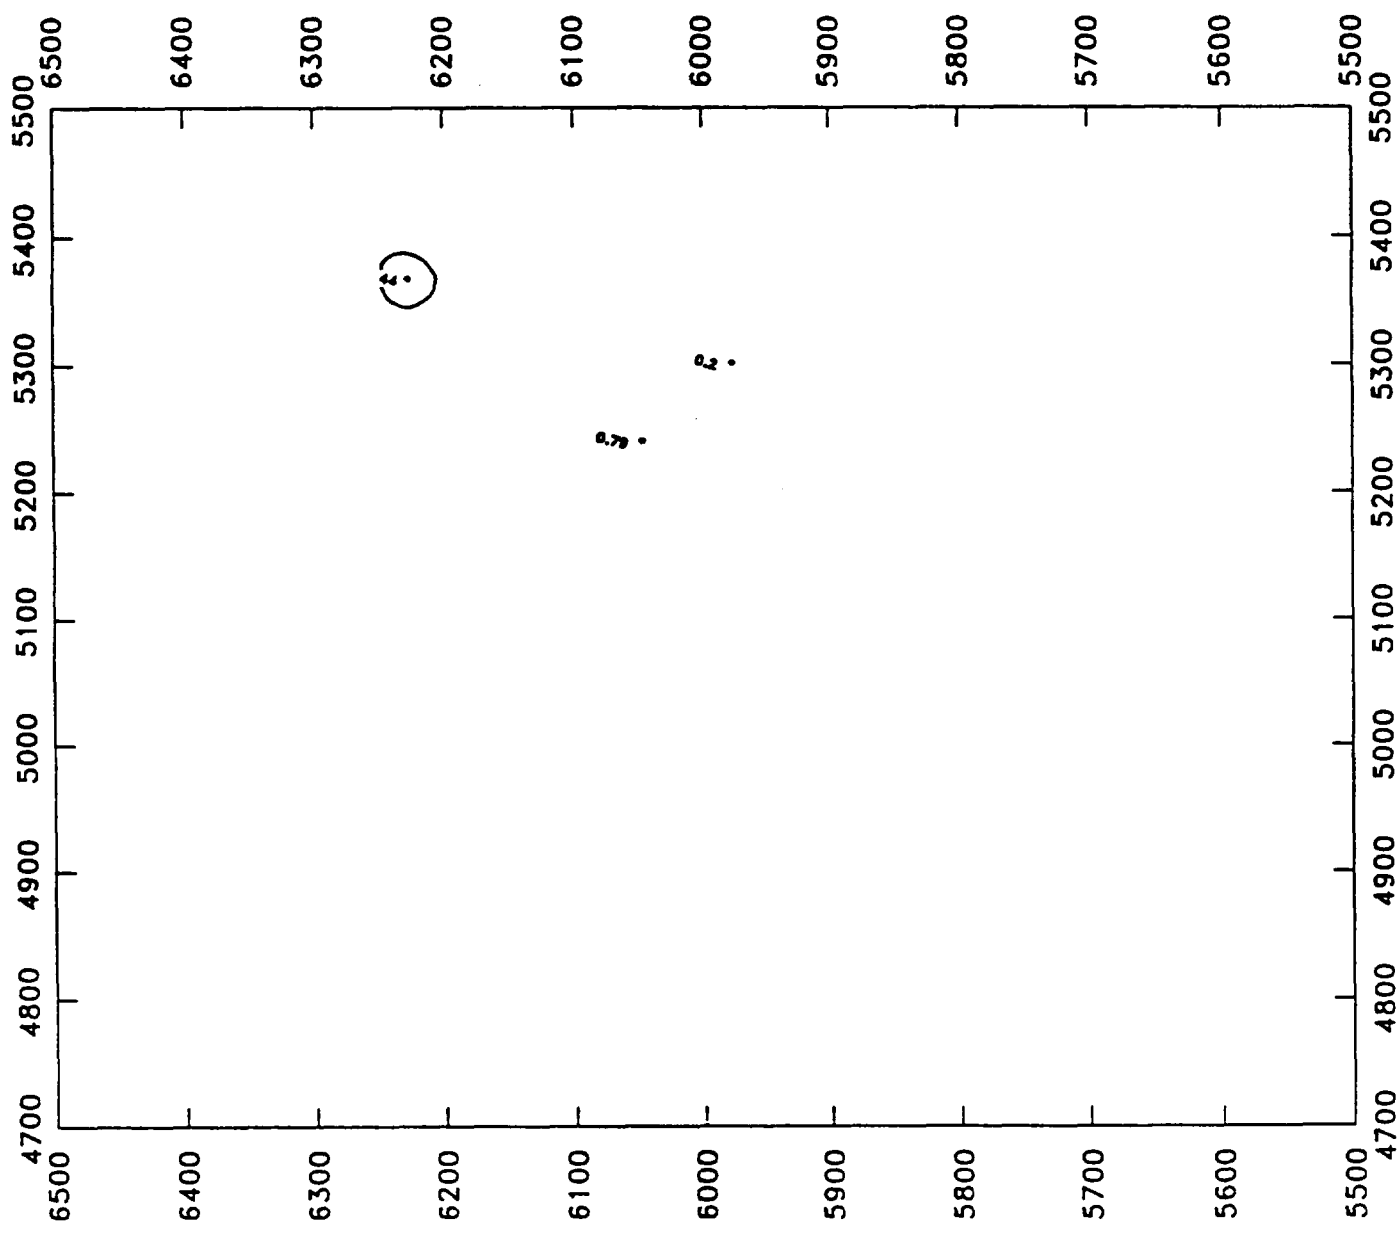
Figure 5-10f Approximate Extent of Total PCB Containing Wastes (> 1 ppm, shaded > 50 ppm), Off-Site Areas (17-20 feet below surface)

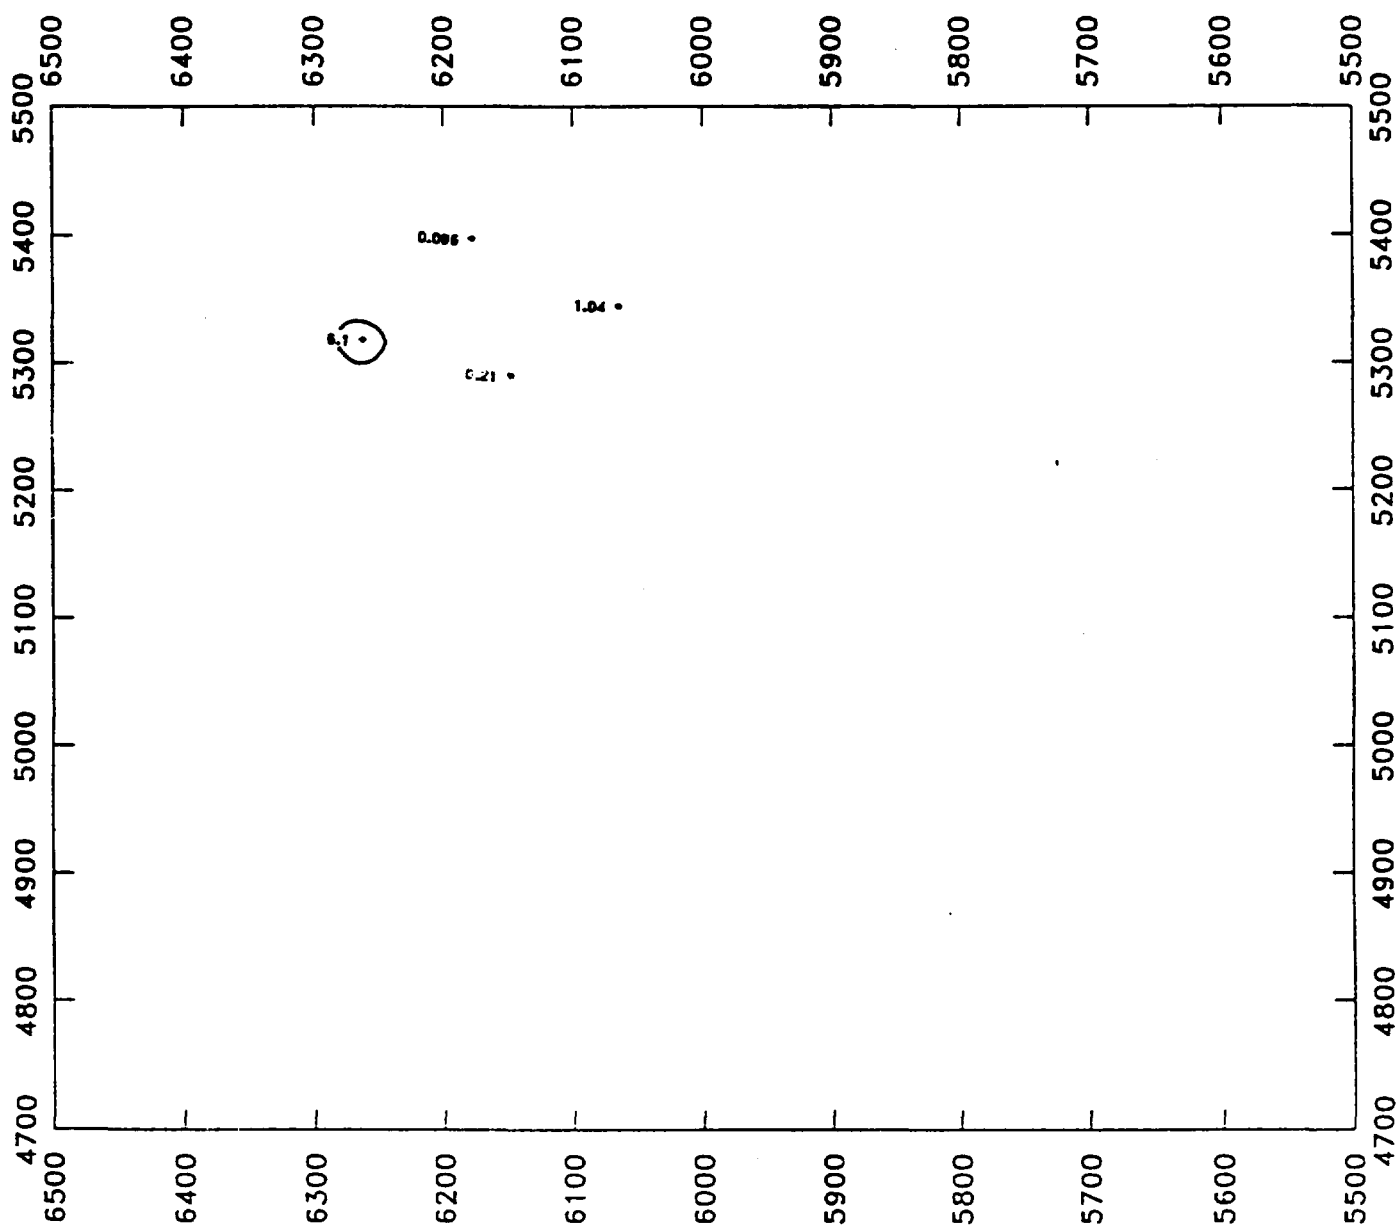
Figure 5-10g Approximate Extent of Total PCB Containing Wastes (> 1 ppm, shaded > 50 ppm), Off-Site Areas (24-26 feet below surface)

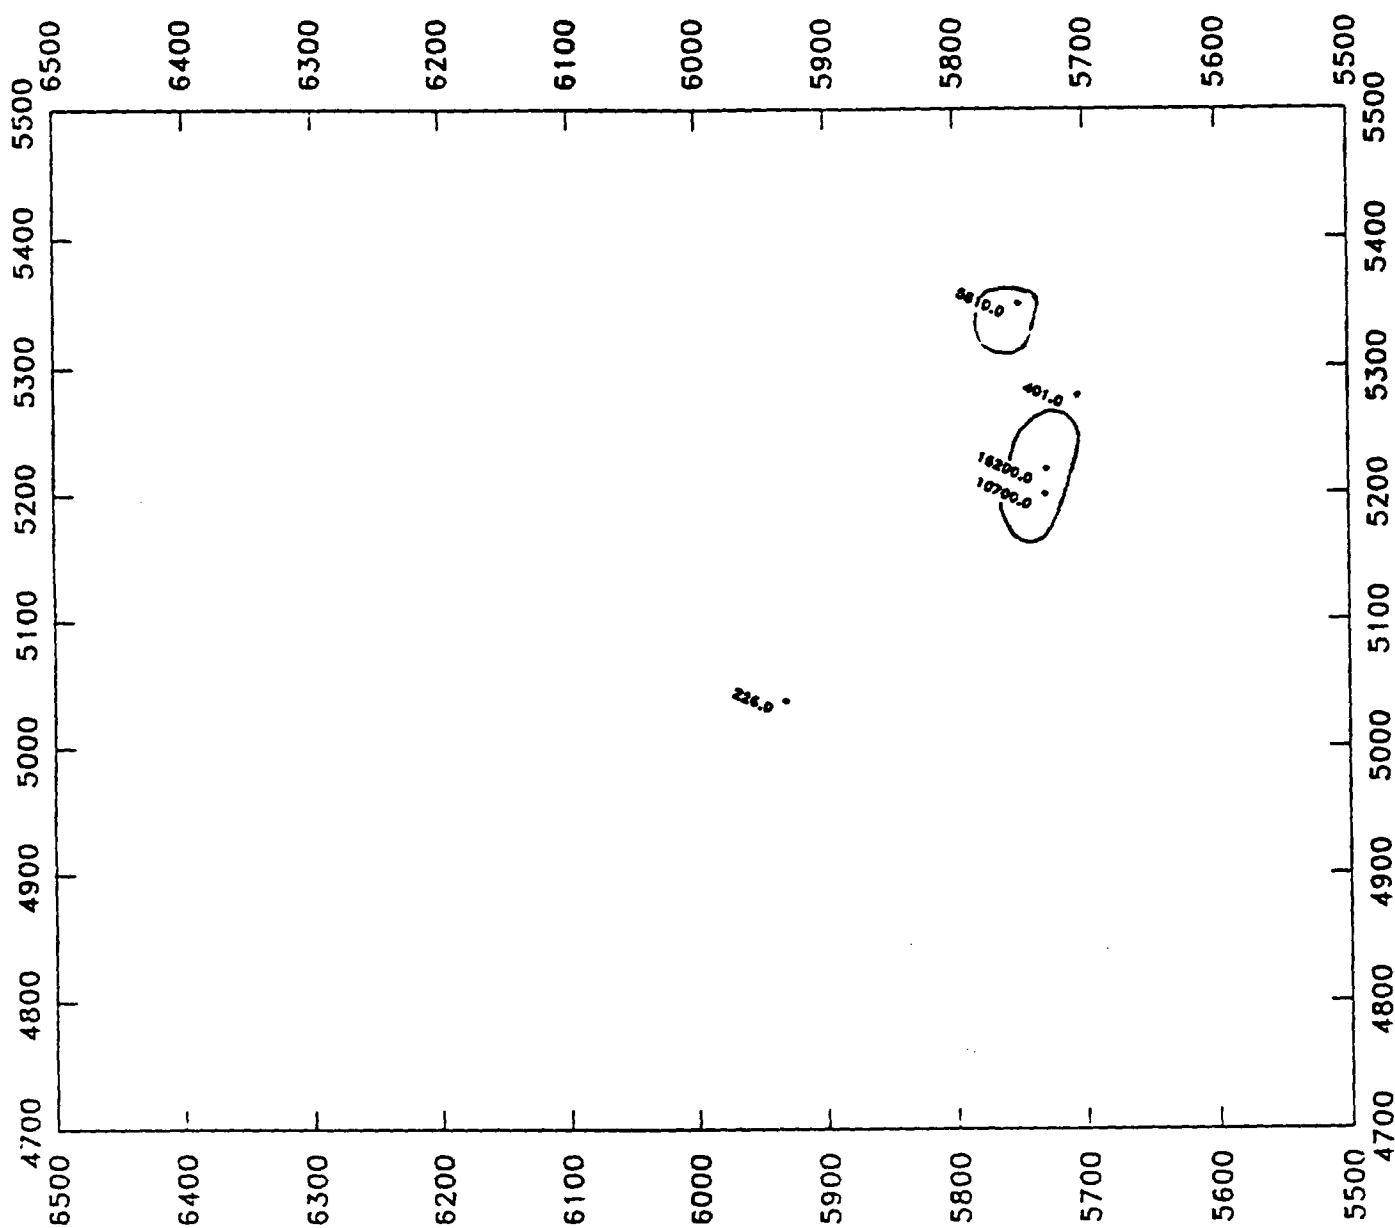
Figure 5-11a Approximate Extent of Lead Containing Wastes (> 500 ppm), Off-Site Areas (1-4 feet below surface). Posted Values are in ppm (mg/kg).

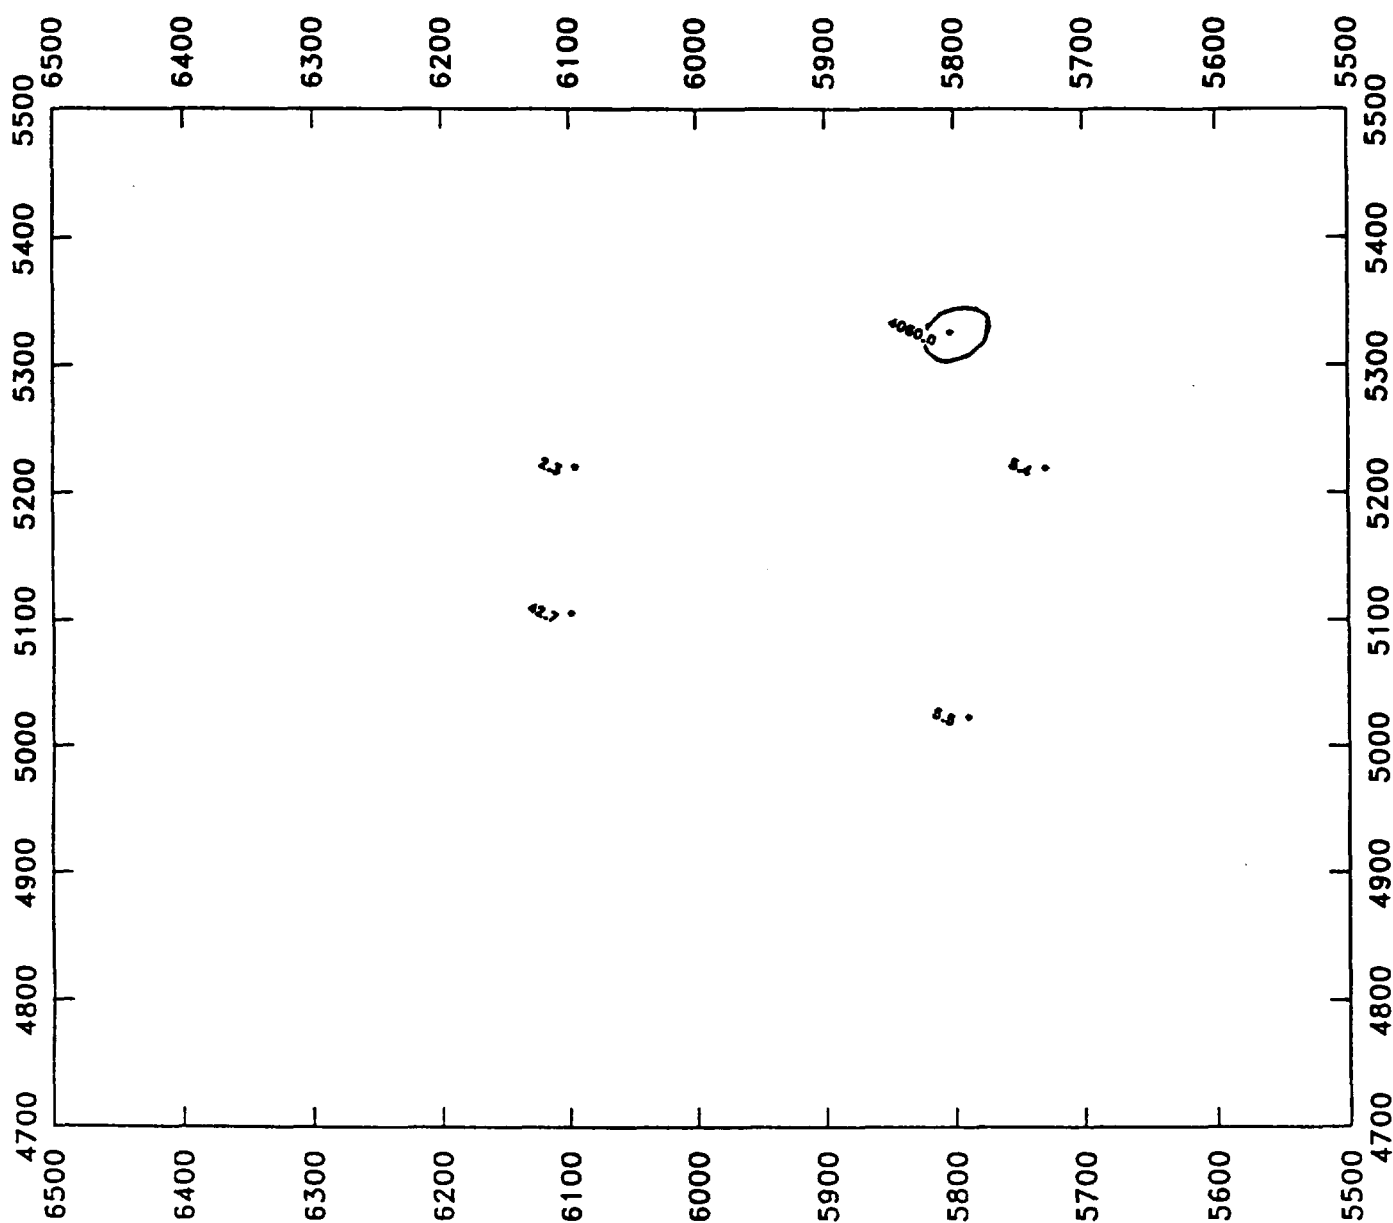
Figure 5-11b Approximate Extent of Lead Containing Wastes (> 500 ppm), Off-Site Areas (4-7 feet below surface). Posted Values are in ppm (mg/kg).
